## MEMORANDUM FOR RECORD

SUBJECT: Joint Inspection of Grassy Island Dredge Disposal Facility located in the Detroit River near Wyandotte, Michigan

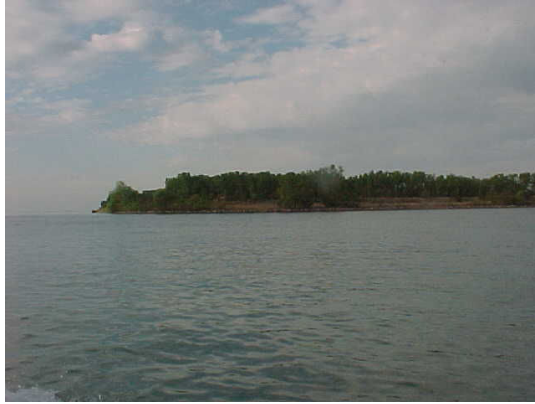
17 May 06  
 Photo: 1 - View from boat  
 of Grassy Island

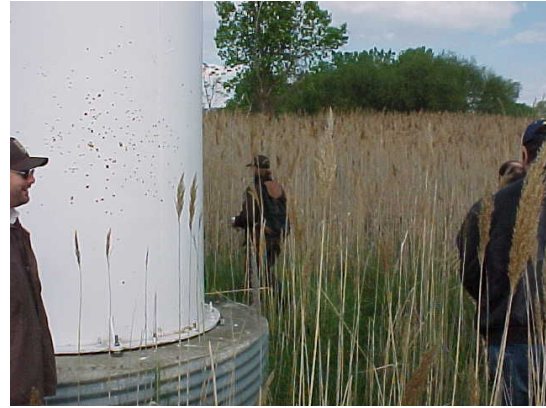
17 May 06  
 Photo: 2 - Begin of  
 inspection  
 at the steel sheet pile dock,  
 by the navigational aid, on  
 the east side of the island

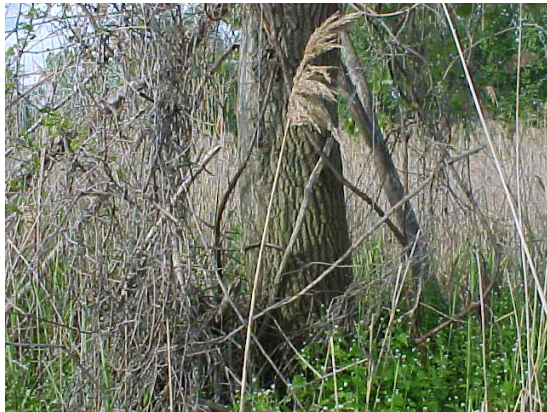
17 May 06  
 Photo: 3 - Large Trees  
 On bank of Interior  
 Dike

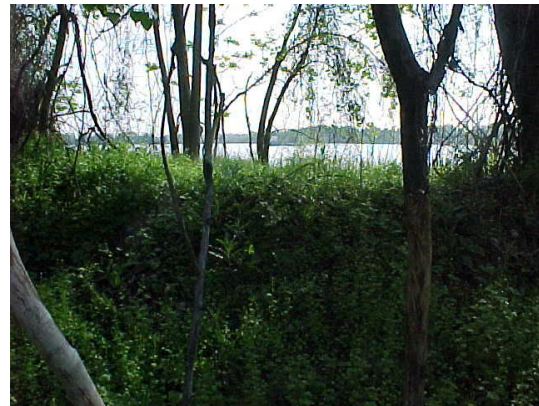
17 May 06  
 Photo: 4 - Trees & vegetation  
 Growth on bank of  
 Interior Dike

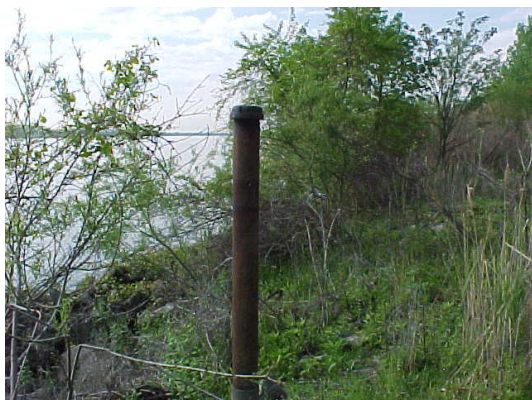
17 May 06  
 Photo: 5 - Monitoring Well  
 On bank Of interior  
 dike

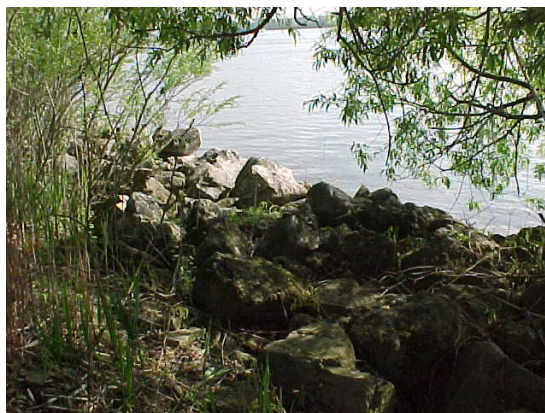
6. **SUMMARY OF OBSERVATIONS:**
  - a.) Many large trees growing on the outside dike risked the integrity of the dike.
  - b.) Holes in the dike caused by animals burrowing needed to be filled.

17 May 06  
 Photo: 6 - Trees on bank  
 of exterior riprap  
 dike

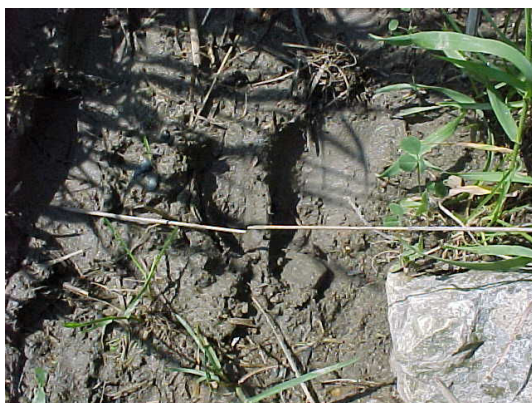
- e.) Ponded water noticed between exterior and interior dikes due to heavy rainfall

in the area during the previous week.

17 May 06  
 Photo: 7 - Wet area between  
 Interior and exterior  
 dikes

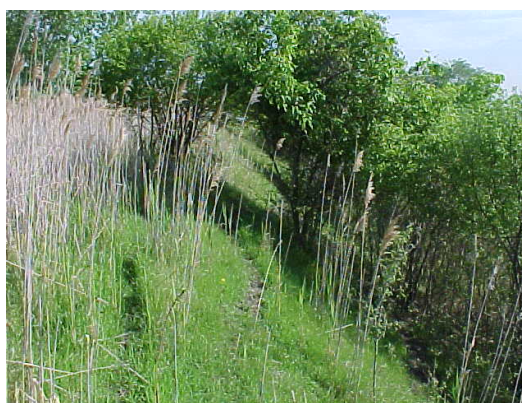
17 May 06  
 Photo: 8 - Extensive trees  
 on bank of interior  
 dike

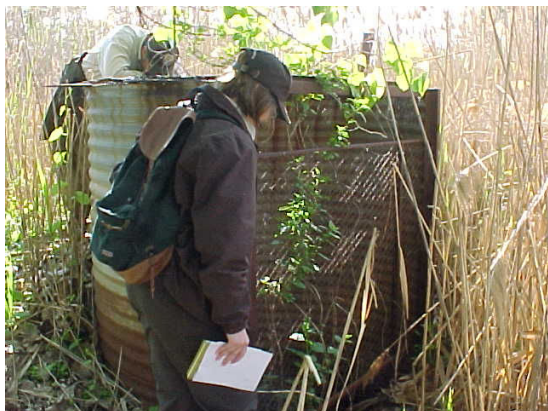
- c.) The condition of the north weir was good, except skimmers might be needed to be attached to prevent debris from entering the weir.
  - d.) Some ponds of water noticed between exterior and interior dikes.

17 May 06  
Photo: 9 Weir Structure

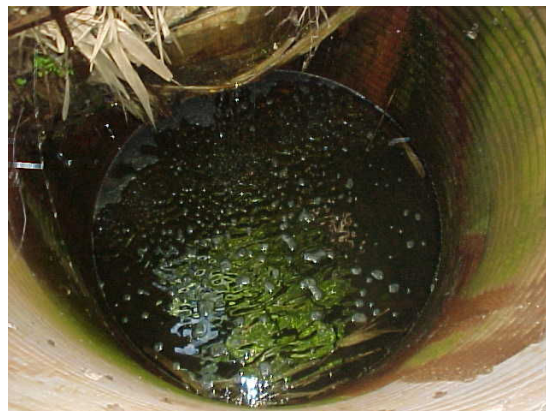
17 May 06  
Photo: 10 - Inside Weir Structure

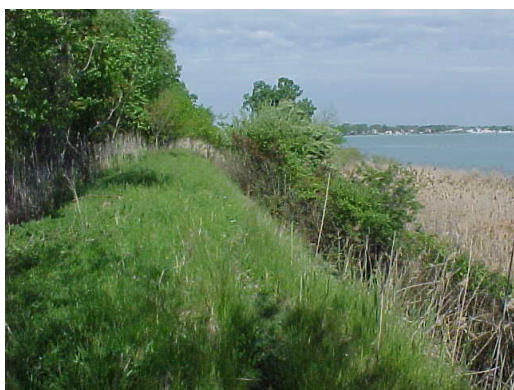
17 May 06  
Photo: 11 - View of top of interior dike

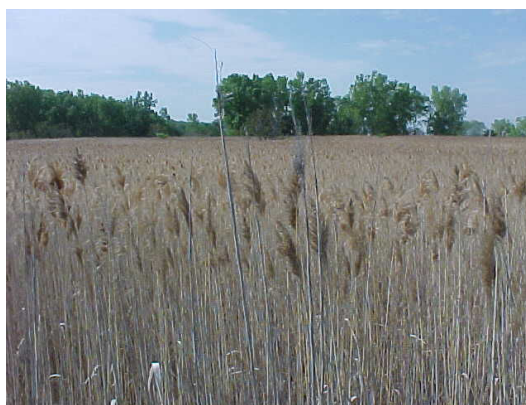
17 May 06  
Photo: 12-Cross Dike

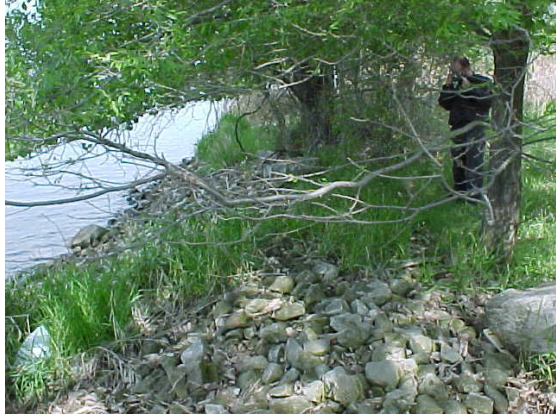
17 May 06

Photo: 13 - Large trees growth  
on bank of exterior  
dike

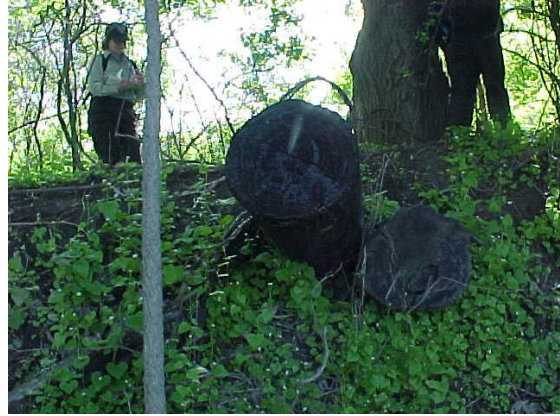
17 May 06

Photo: 14 - Large utility pole  
Buried in interior  
dike bank

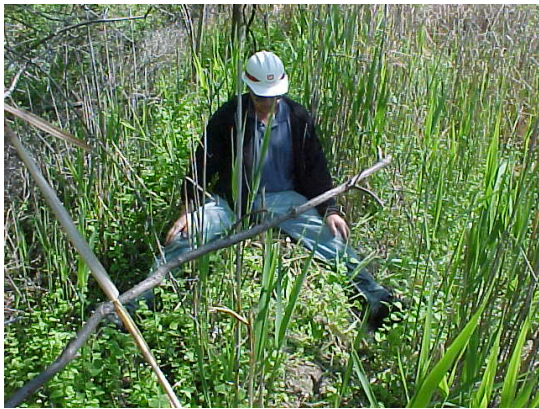
17 May 06

- a.) The overall condition of the dikes appeared good, but the interior dike was observed to have areas in which it was eroded to a narrow barrier, in some places it was as narrow as approximately 1' in width. However, additional testing is necessary if any significant changes are going to be made to the structure (e.g. placement of additional fill material or a cap).

Photo: 15 - Top of Narrow  
Interior Dike

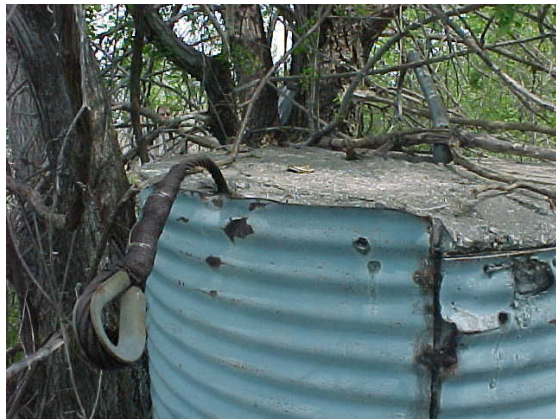
17 May 06

- b.) Many trees grew between the two dikes surrounding the island.
  - c.) The outfall structure on the north end of the island was working. The south end of the island had a structure resembling a weir but it was filled with concrete and not functional.

Photo: 16 - Abandoned concrete  
filled structure

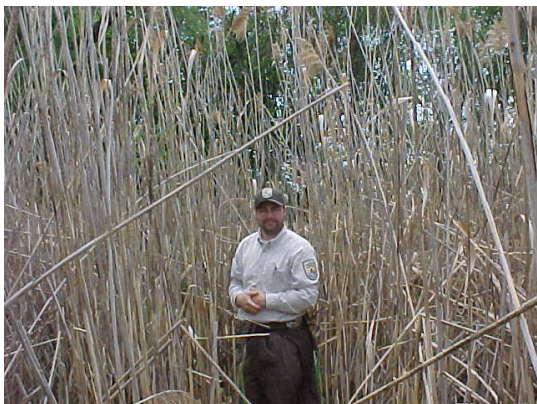
17 May 06

Photo: 17 - Tall grass between  
Interior and exterior  
dikes

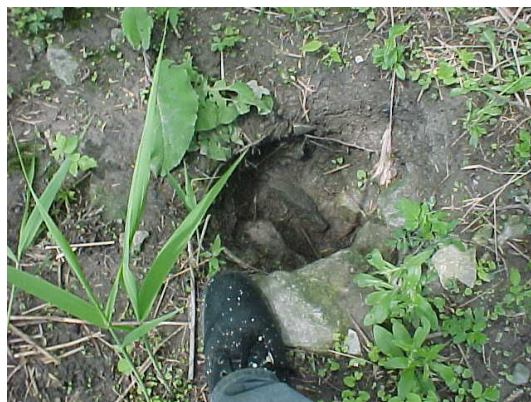
17 May 06

Photo: 18 - Burrow hole  
between interior  
and exterior dikes

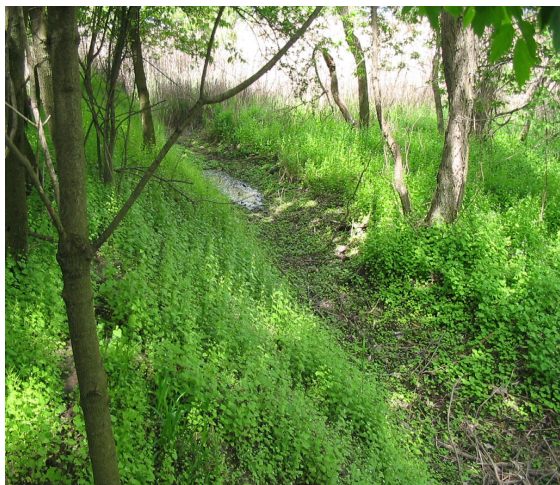
17 May 06

Photo 19 - Drainage ditch along  
toe of interior dike

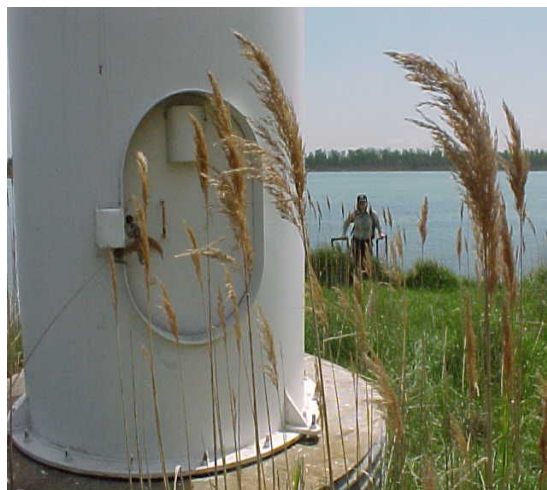
Photo: 20 - End of Inspection  
at the steel sheet pile ,  
by the navigational aid,  
east side of the island  
dock
